Study on Negative Effects of Corona & its Consequences on Polymer Insulators and Remedial Action

Prepared by Mr. Pankaj Kakoti (Manager-Products)
& Mr. Naushad Ansari (Sr. Product Engineer)
Taurus Powertronics, Bangalore

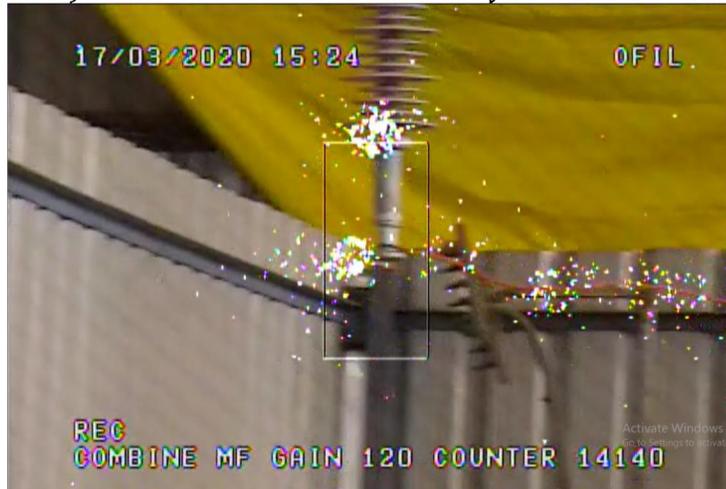
a) Test conducted on Polluted Polymer insulator containing without moisture.

Finding: Corona found at 140 KV near 1st Shed, no corona at string. Attached photo.

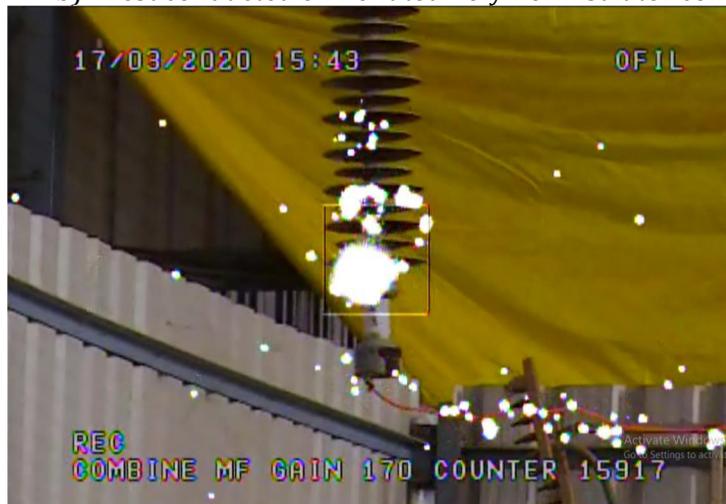
b) Test conducted on Polluted Polymer insulator containing with moisture

Under wetting conditions, patches of surface water form in regions of lower hydrophobicity and are separated by dry regions or 'bands' Localized arcs are form, bridging gaps between water patches further stressing the rubber

Findings- Insulator Containing Pollution and Moist was found with High Corona accumulated on sheds of Insulator.

Remarks- Corona over Insulator shed creates a tracking path for discharge that's leads to ageing of the insulators. This is loss of physical properties over time, reducing their dielectric and mechanical withstand. This continuing exposure to corona resulted in cracks in the rubber sheath and degradation of the end fitting seal. Once a seal is compromised, moisture can come into contact with the fiberglass rod, leading to brittle fracture. Brittle fracture is a mechanical failure of the rod due to acid attack and where the fracture exhibits one or more smooth planar surfaces – mainly perpendicular to the axis of the rod and giving the appearance of the rod being cut.

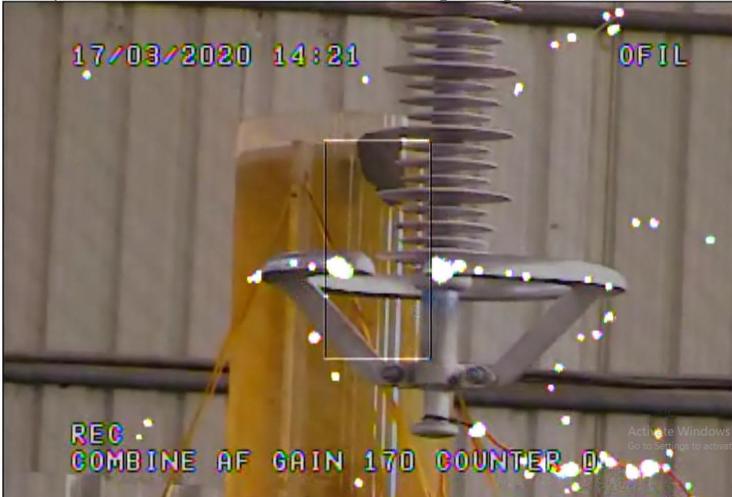
a) Good Insulator with Grading Ring

Finding: Insulator with proper Grading was observed with No corona on insulators with applied Voltage of 150 kV corona found only at the ring.

Remarks-If Grading ring is not installed Properly or installed in correct place or uniformly connected all possible corona generated will be on the insulator disc and makes the insulator failure in Long run.

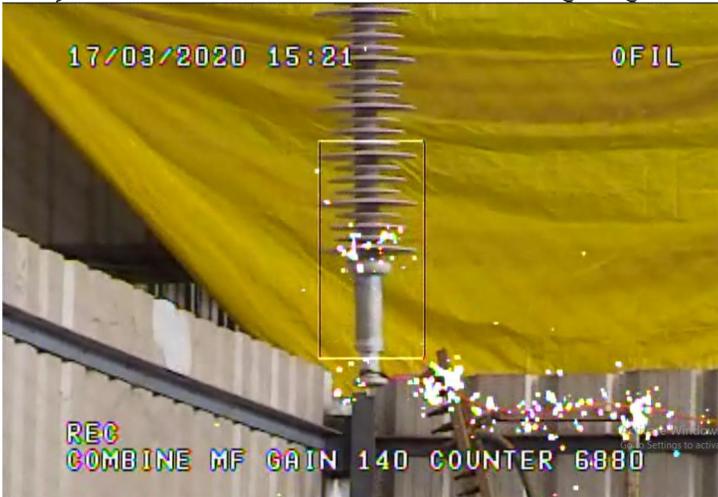
b) Good Insulator tested without Grading Ring:

Finding-Insulator without grading ring was observed with corona at First shed of Insulators with Applied Voltage of 140 kV.

Remarks-In High voltage Transmission Line above 220 kV, Proper Installation of Grading Ring helps to minimize the effect of Corona and Improve the life of Insulators, Improper Installation or Missing of Grading ring could be a major reason for harming the healthiness of Insulator and Transmission Line.

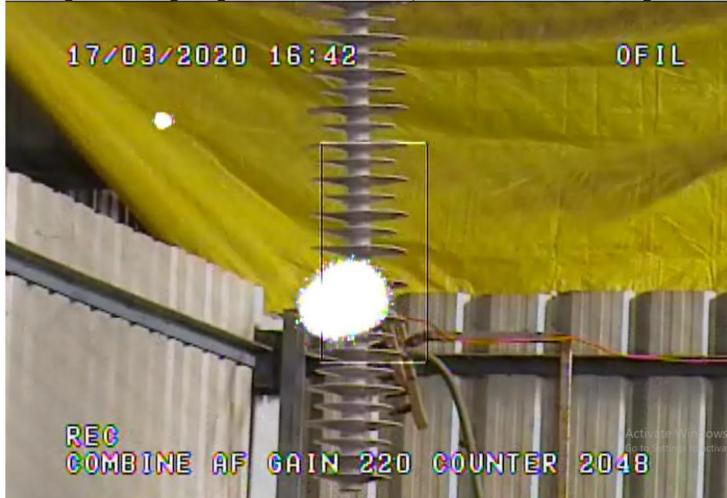
Setup III: Improper Hardware joint created temporarily on Polymer insulator.

In High voltages Transmission line i.e., 220 kV and above if Hardware joints of Insulators are loose, partial discharge will occur due to ionization of air hence followed by electrical arcing. This will make insulator get fail early due to deposition of nitric acid.

Finding- Corona was found on the Insulators Joint due to improper Hardware Joint Connection.

Remarks -High Corona discharge were observed at 70 kV applied Voltage, with increase in applied voltage Corona intensity will increase resulting breakdown of the Line.

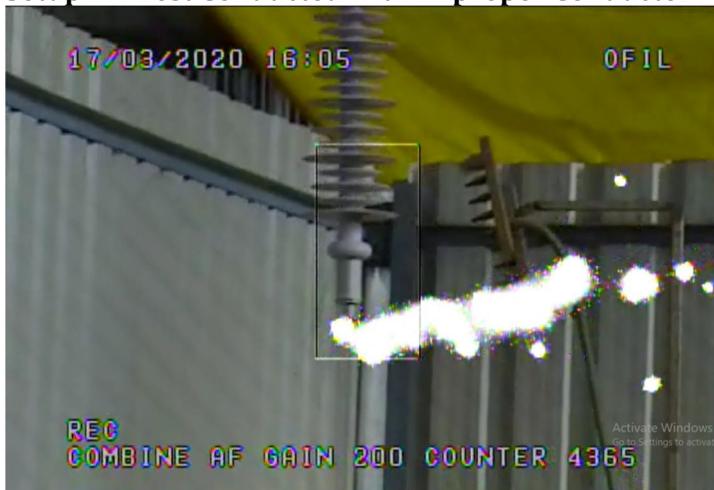
Setup-IV: Test Conducted with Improper Conductor

Improper Conductor or Open Conductor strands ionize the air particles leads to create a virtual conductor promoting the power lose, it also enhances the deposition of Nitric acid on conductor.

Findings-High intensity of Corona was found on Conductor with hissing Noise.

Remarks- Bad Conductor or Conductor with open strand promote Corona Discharge, increases loss of physical properties over time, reducing their dielectric and mechanical withstand.

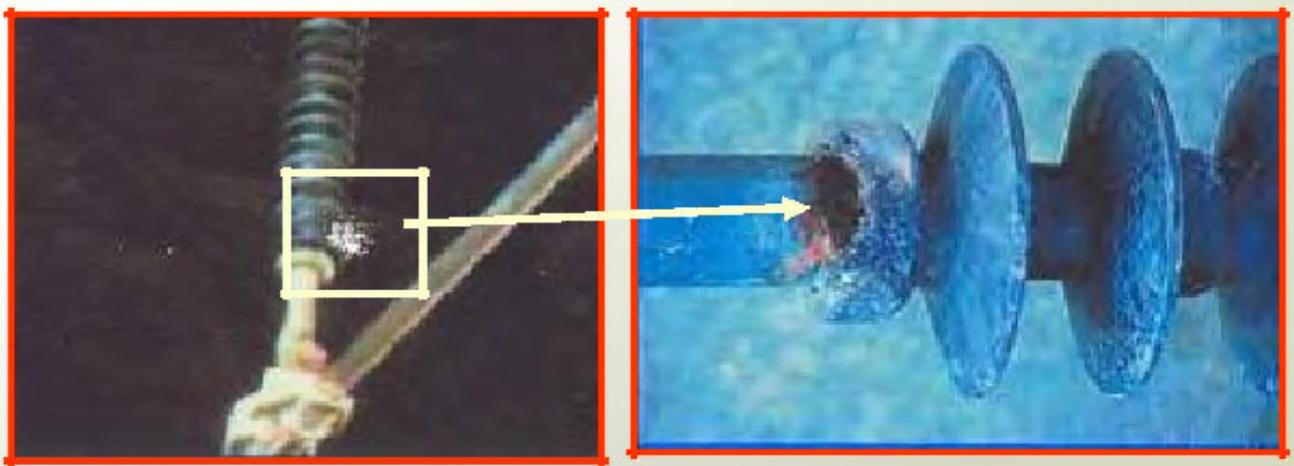
Failing end fitting Seal

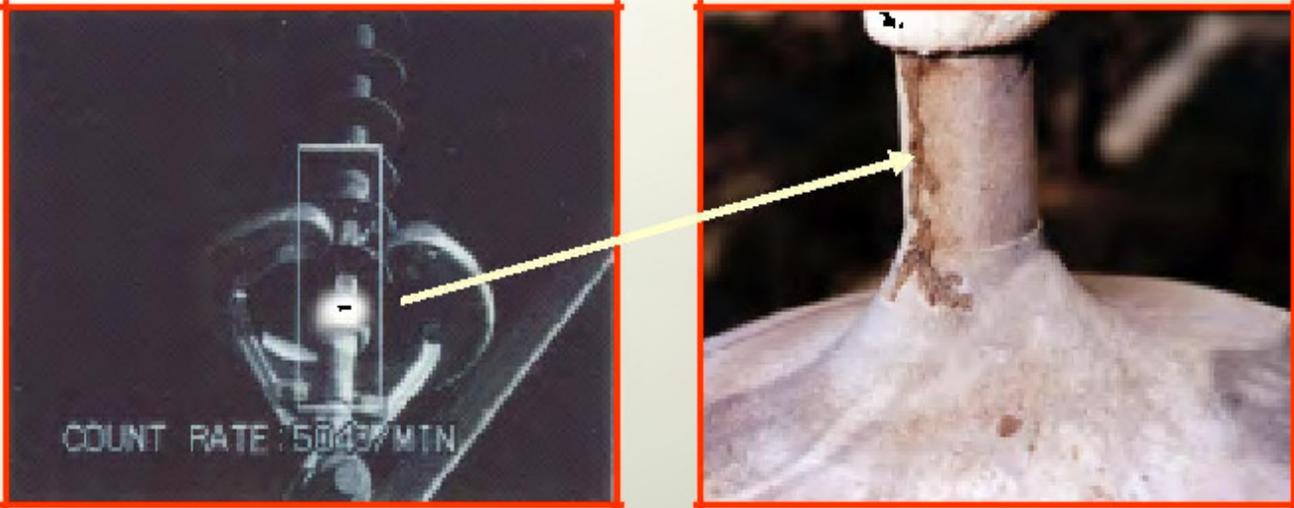
Surface Tracking

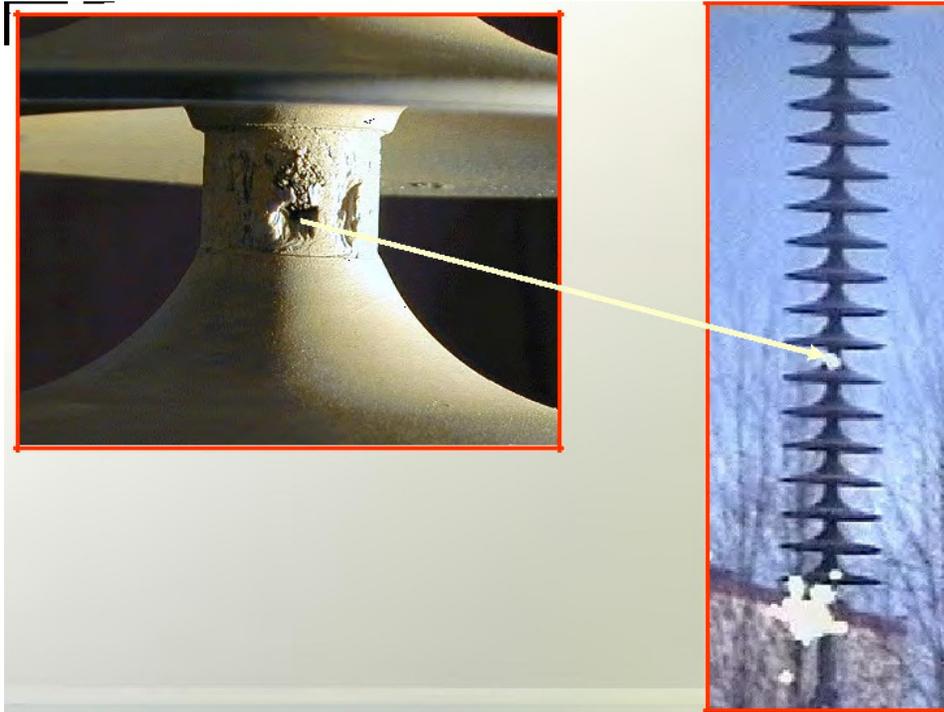
Erosion of material on the surface
