New Concept & Methodology to Check the Insulators Health to Enhance the Performance of Overhead Lines by Measurement of Tower Leakage Current & Ultrasound Detection

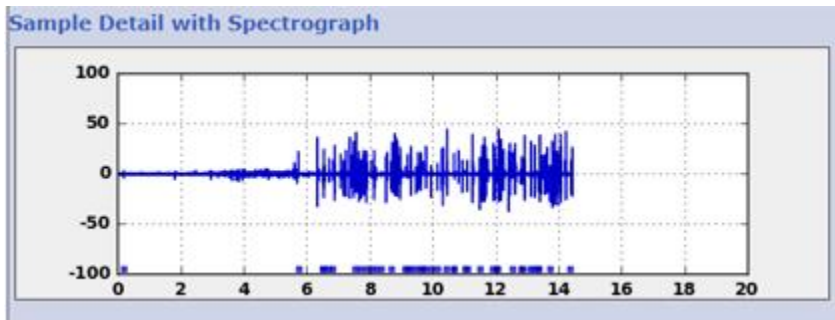
Partial discharge graph (400 KV S/C Korba Bhatapara LOC NO 193 (Y phase))

SI No	Line Name	Tower Location No	Insulator Type	Tower Leakage Current (mA)				Total leakage current (mA)	Partial Discharge(Ultrasound)Scanning	PID report
				Leg A	Leg B	Leg C	Leg D			
1	400kV Korba – Bhatapara line	193	Porcelain	94	78	114	112	398	Partial Discharge (Ultrasound)observed in Y phase and B phase	Matched with the report
2	400kV Korba – Bhatapara line	194	Porcelain	126	67	98	78	369	Partial Discharge (Ultrasound)observed in Y phase	“
3	400kV Korba – Bhatapara line	202	Porcelain	78	32	114	88	312	Partial Discharge (Ultrasound)observed in Y phase and R phase.No Partial discharge found in PH B	“
