Corona effect on Composite/Polymer Insulators

THIRD HARMONIC LEAKAGE CURRENT MEASUREMENT AND HEALTH MONITORING OF SURGE ARRESTERS-B1 METHOD- QUICK, ACCURATE, SIMPLE & SAFE

NEW CONCEPT & METHODOLOGY ON TOWER LEAKAGE CURRENT MEASUREMENT & ULTRASOUND DETECTION FOR INSULATORS HEALTHINESS

TAURUS POWERTRONICS PVT LIMITED

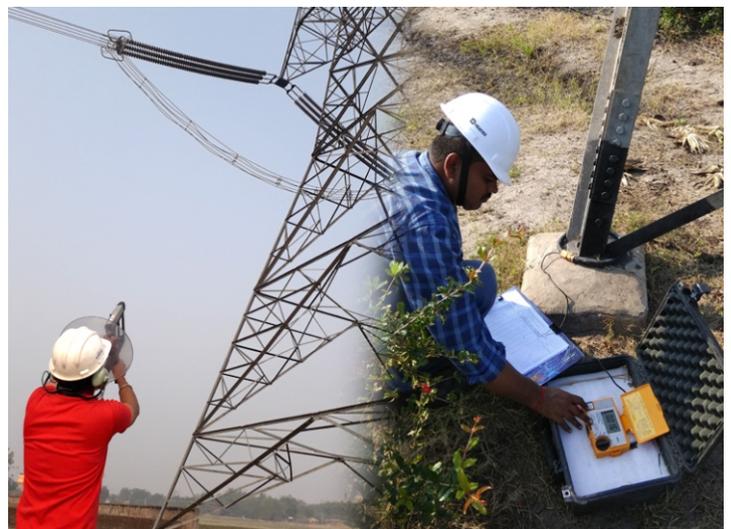
Our newly launched product LID gained excellent momentum during last quarter. Using this innovative equipment, one can detect punctured insulators in a substation or a tower from a safe distance without climbing up the tower. We had many successful demonstration of this product at several customer places. Everybody found this equipment very useful and appreciated this innovative product. The future for this product is very good. Also we received an order for our STITAM division for inspecting the tower line insulators using this equipment. A special mobile app is being developed to capture the readings in digital format which will be helpful in making the trend analysis.

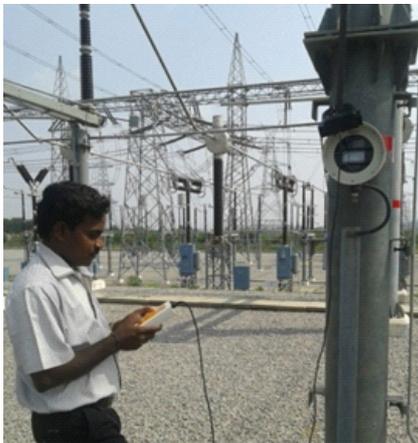
TESTING METHODOLOGY:

- Insert the plug of CT to the position "CT INPUT" of the instrument body.
- Clamp CT to the Earth wire coming from Surge Arrester to Surge meter/counter, make sure clamp CT before the surge meter.
- Set mode switch to "RMS" position and range switch on 300µA.
- If "OL" sign display on LCD, change the range switch to 3mA.
- Wait for 5sec so that the displayed values get stable and note it down.
- Change the mode switch to "1st H" & "3rd H" and repeat step 5.

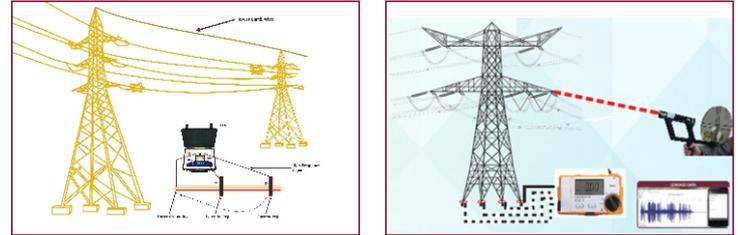
Fig-A

New concept has been found to check the Leaky Insulator by measuring the Tower Leakage Current & conducting the Ultrasound Detection with equipment typically (TAURUS-LID) on Insulator Strings to Identify the Leaky Insulators. Basically Methodology has been categorized in two part as mentioned below & shown in Fig-B

1. Measurement of Leakage Current at Tower Legs, three setup has been shown & explained: (Any one setup can be used as per requirement of the site)

- a) FCM-100 (200mm Diameter CT Sensor)- Shown in Fig-1
- b) FCM-400 (400mm Diameter CT Sensor)- Shown in Fig-2
