Study on Negative Effects of Corona & its Consequences on Polymer Insulators and Remedial Action

Prepared by Mr. Pankaj Kakoti (Manager-Products)
& Mr. Naushad Ansari (Sr. Product Engineer)
Taurus Powertronics, Bangalore

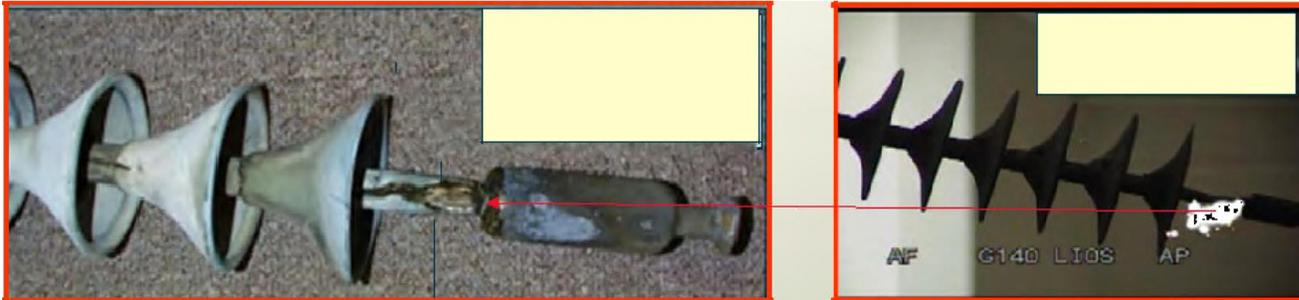
Few Photos from the field: Degradation of Polymer Insulators due to negative effects of Corona:

To get to that point is to waste your time & money
Detect this failure in advance to take the right action on time
