STITAM

Surge Arrester Inspection

We Taurus offer services to identify underperforming Surge Arresters, so that they can be replaced with new Surge Arresters. Resistive Leakage Current measurement, Thermovision Scanning to check temperature of equipment and Visual Inspection is carried out to detect the healthiness of the Surge Arrester. Ultrasound scanning is also done to detect partial discharge.

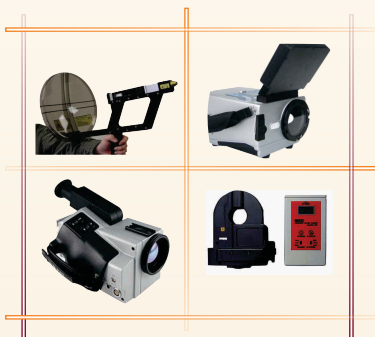
Equipments Used

- **Leakage Current Measurement Unit,**
- **Thermovision Camera**
- **Ultrasonic Scanning Device**
- **Corona Camera**
