# AUMSRI

**ASSET UPTIME MANAGEMENT &  
SPECIALIZED REFURBISHMENT OF INFRASTRUCTURE**

**TRANSMISSION TOWER HEALTH ASSESSMENT (TTHA)  
IN ONLINE CONDITION “NO SHUTDOWN REQUIRED”**

# Transmission Tower Health Assessment in online condition “No Shutdown Required”

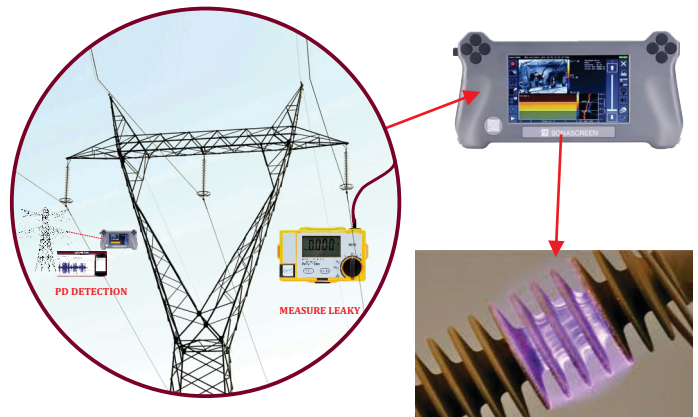
Innovative Flexible CT been using to measure leakage of the tower. High leakage tower are suspecting for the leaky insulator.

This Leakage Current Measurement is a quick, safe and effective method of identifying towers having weak insulators. Flexible AC/DC Clamp meter from reputed Japanese company MULTI is used to measure the leakage current of the tower body.

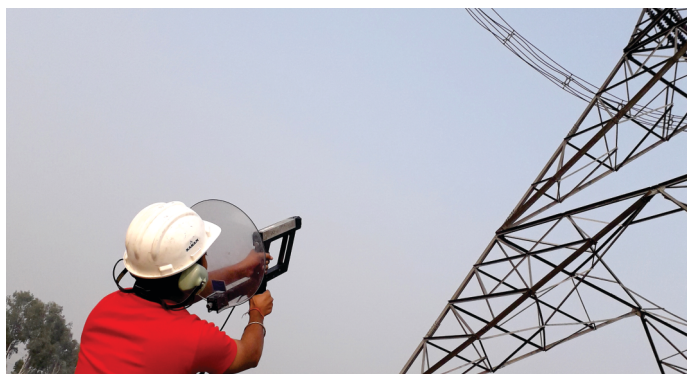
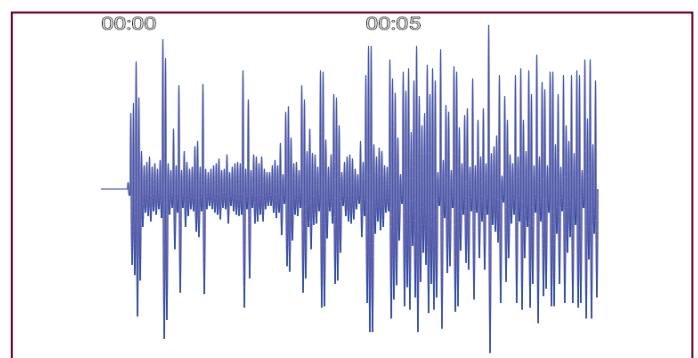
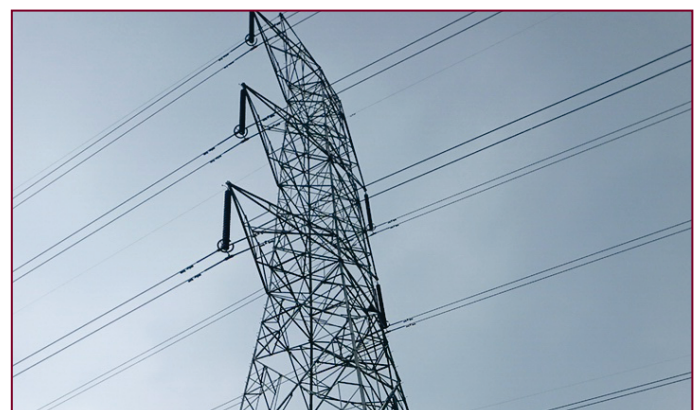
Audio and video acoustic leak detection method is using to detect leaky insulator of the tower.

Leaky insulator Emitting extra high frequency. The noise emitted is at very high frequency hence not audible to human ear. A new technique Audio and Video scanning is being used in detecting damaged, cracked or Punctured Insulators in Transmission Line and in Substation.

Using this Hi-tech ultrasound equipment, we Taurus Powertronics inspect Transmission Line insulators for any suspected abnormality.

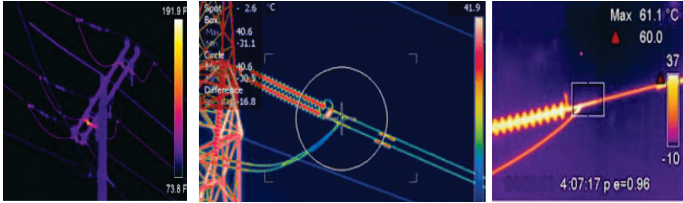
Hot spot is not visible to naked eyes unless it becomes too hot. We Taurus Powertronics provide Hot Spot detection service using latest IR Thermovision camera.

As seen in above pictures Thermovision Scanning is done for dead-end joints and Mid-span joints. Both digital and thermal images are provided in the report for easy mapping and comparison. Tower Number, Phase, Side are clearly mentioned in the report for easy identification of the joints, so that remedial action can be taken without any confusion.

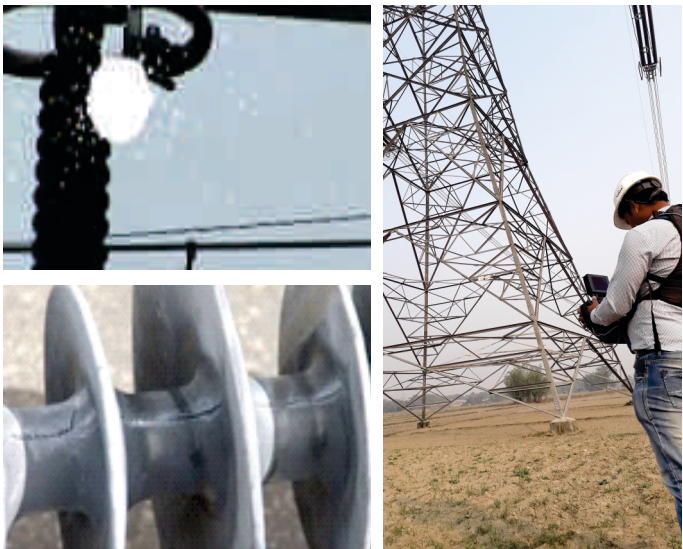
Ultra High sensitive Daytime Corona Camera is used to capture corona even during broad day light.

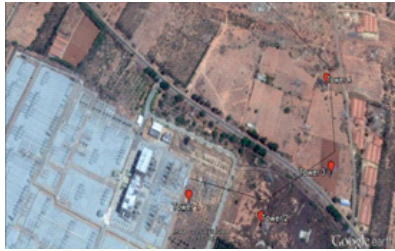
The very popular mapping tool, "Google Maps" allows you to make your own map using details. Wherein the geo location of each tower is feed in and lines are drawn between these towers. This kind of ready map is very helpful in understanding the terrain and also it is

easy to explain the staff about the route of the line and surrounding area. The basic requirement to do so is to capture Geo Location of each tower in the line.

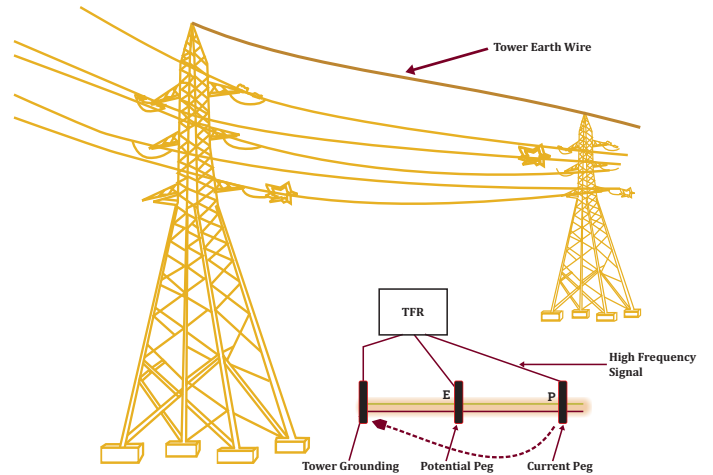
We Taurus Powertronics carry out measuring of Tower Footing Earth Resistance, Impedance & Inductance without removing the top earth-wire but the towers are virtually isolated from each other by injecting high frequency.

The entire procedure is carried out as per IEEE standard
